Fire Risk Assessment

Montgomery House
Hawthorne Road
Oldham
Greater Manchester
OL8 3QG

22 August 2023

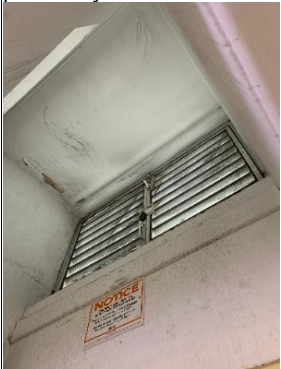
Ref	COMMENTARY
8.2	<p>The permanent vent at the head of the stairs has an insect screen mesh on the inside and remains clear of dust and debris as previously recommended for cleaning.</p>

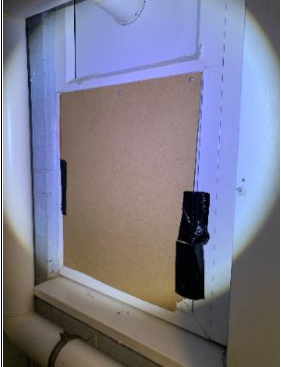
Ref	SIGNIFICANT FINDINGS
	Observation
9.1	<p>The bathroom window to flat 18 on the 5th floor was smashed and covered with a thin piece of plywood. Where the glazing units do not offer a reasonable level of fire/smoke resistance, a fire or other products of combustion may be able to spread onto the escape route, placing persons at risk of harm.</p>

9.1	<p>It is recommended to replace the damaged window unit with a certified 30 minute fire resisting window unit that is fixed shut, rather than replacing it like for like. This would improve the compartmentation between the flats and drying rooms. See 9.1's commentary for further information.</p>
	Observation

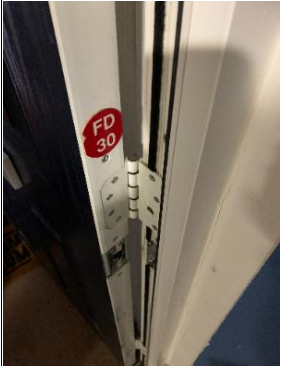
9.1	<p>It is recommended that the refuse chute door is repaired to enable the door to fully close shut.</p>
	Observation
9.5	<p>The entrance door to flat 32 did not self-close due to it sticking on the carpet, and the entrance door to flat 26 had its self-closing device removed. Where fire doors do not self-close, a fire or other products of combustion may be able to spread onto the escape route, placing persons at risk of harm. Note: The onsite representative raised a job on the day of the visit for works to be undertaken.</p>

9.5	<p>It is recommended that the self-closing device be reinstated, and a solution sought for the door that sticks on the carpet, to enable doors to fully close into their rebates unaided.</p>
	Observation

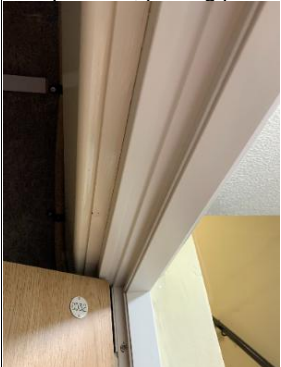
9.6	<p>The understairs electrical cupboard was found missing intumescent fire and cold smoke seals on the top edge of the door frame. Where fire door sets are missing components, a fire or other products of combustion may be able to spread onto the escape route, placing persons at risk of harm.</p>

Recommended Actions
9.6	It is recommended that intumescent fire and cold smoke seals are reinstated on the door identified.
	Observation
9.8	<p>Breaches in compartmentation were identified within the communal areas in the block. These include:</p> <ul style="list-style-type: none"> • The caretaker room/office on the ground floor had rockwool used as a temporary seal around pipework. • A wall vent was not sealed in the drying room on the 6th floor at high level. <p>Breaches in fire-resisting construction that are not suitably fire stopped could lead to a fire spreading beyond the compartment of fire origin and place persons at risk of harm.</p>

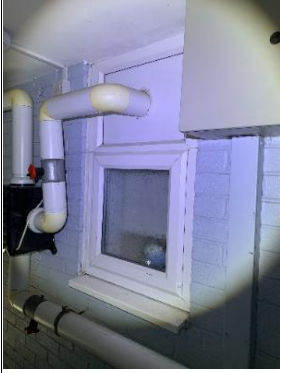
Ref	COMMENTARY
9.1	<p>The previous FRA raised an action in relation to the bathroom windows of flats that open up into the drying rooms being mechanically screwed/fixated shut, as there is a low risk that ambient temperature smoke from a smouldering fire may spread beyond the flat of fire origin via open bathroom/ WC windows to affect a neighbouring flat which may lead to a slight risk of harm to the immediate neighbouring resident/s. This is comparable to smoke spreading externally via an open window and re-entering the building through another open window at a different level. The previous FRA action has not been signed off as complete on Aurora. However, as an alternative to the other recommendations and to totally prevent the risk of any smoke spread via the windows no matter how small, the windows have been mechanically (screwed/nailed) sealed shut thus preventing any ambient smoke spread from flat to flat horizontally. The risk of smoke spreading vertically via open windows on the external wall would remain the same.</p> <p>Sprinkler systems are activated by heat from the fire, and release water onto it. They are designed to prevent the fire from growing so that much less smoke and heat are produced and people have more time to escape. In many cases, a sprinkler system will put the fire out. The installation of the residential sprinkler system in the flats/ventilated landing is highly likely to reduce the risk of fire spreading across the ventilated landing. In the unlikely event of fire spreading onto the ventilated landing before the sprinklers become effective, the addition of a heat detector located in the landing provides an early warning of fire for the immediate neighbouring resident/s. The ventilation area has been increased by the removal of sections of acrylic sheeting following previous recommendations bearing in mind advice from the gas engineer, thus allowing a greater volume of smoke to ventilate to the atmosphere from the landing.</p> <p>The risk of harm to relevant persons is assessed as low due to the mitigating measures taken above. However; If future renovation works occur, or window units become damaged, it would be advisable to upgrade the bathroom window units to ones that are fixed shut and provide 30 minutes of fire resistance.</p> <p>It is noted prior to the installation of sprinklers, a previous serious top floor flat fire which likely achieved flashover when the lounge window failed did not spread to or across the ventilated landing. See 9.11, 9.16's commentary.</p>

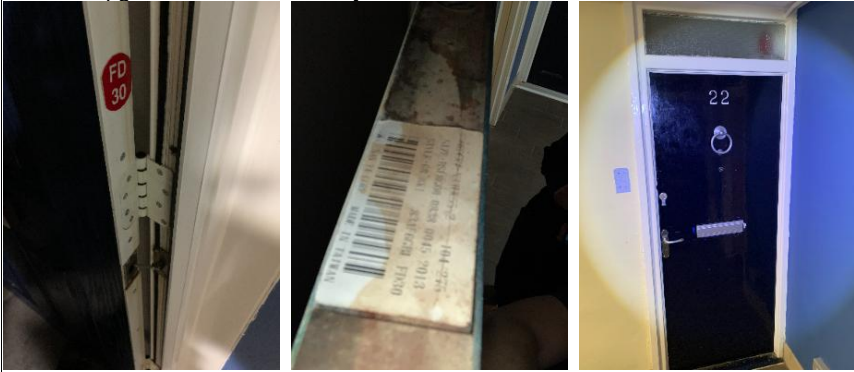
9.1, 9.5-9.6	<p>From the flats accessed, the layout is the same as noted in the flats previously accessed. The entrance doors appear to be robust FD30s self-closing composite fire doors which are a good fit and close fully under the action of the self-closing devices (however, see 9.5's significant finding on a couple not closing/missing self-closers). The person consulted advised that the doors are around 7-10 years old and FCHO has confirmed that these types of doors are only fire tested from one side, and a decision had been made to replace these when they become damaged, which is understood to all have been consulted with the fire service.</p> <p>Test evidence of the performance of the door was available and viewed. A 30 minutes fire resisting doorset report undertaken by Warrington Fire was viewed. The conclusions from that report advise that if the NFS 30 minutes doorset design, constructed in accordance with the specifications documented in the report, were to be tested in accordance with BS476-22:1987, it is the opinion of Warringtonfire that they would provide a minimum of 30 minutes fire resistance integrity performance and insulation (subject to section 20 of the report). The report is valid from 10/10/2019 - 10/10/2024, in which a new report would need to be issued.</p> <p>A report from Exova Warringtonfire was also viewed, to show the test evidence of the performance of the doorset which was dated 15/04/2014 to show that the doorsets had passed the required fire tests.</p> <p>Flat 22's entrance door was different from the rest, however, the person consulted advised that the door is a fire-rated door and was upgraded within the last 2 years with intumescent fire and cold smoke sealed and a self-closing device.</p>

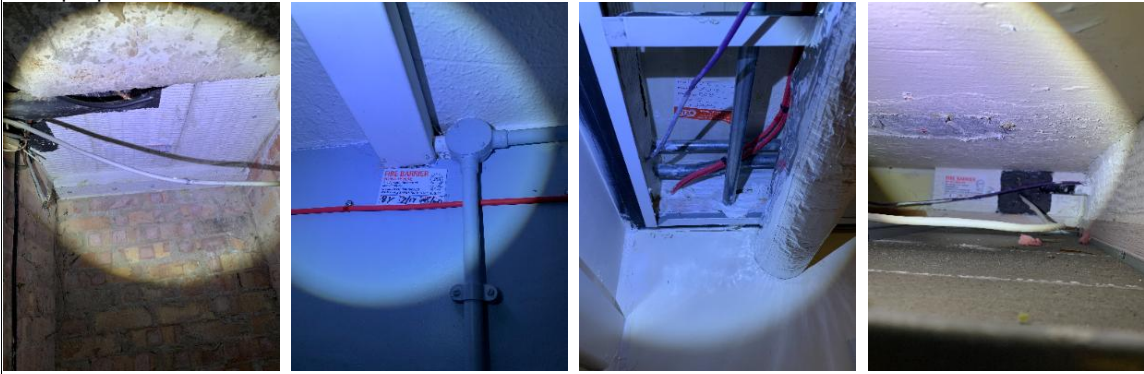
9.8	<p>Onsite observations showed that ground floor plant rooms, ancillary rooms, bin rooms, and other areas were adequately fire stopped including areas above the false ceiling on the ground floor and within the trunking and boxed-in sections (sampled only). However, see 9.8's significant finding. Example pictures:</p>

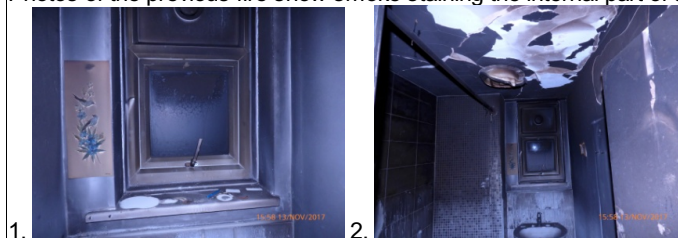
Photos of the previous fire show smoke staining the internal part of the bathroom and WC window frames.

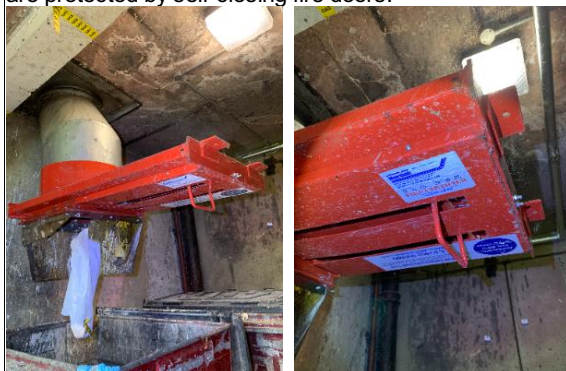
The refuse chute is protected within the externally accessed bin room by means of a spring-loaded gate, connected to a fusible link. The metal gate slides across the base of the refuse chute to provide fire separation if the temperature from a fire in a bin causes the link to melt. The operation of the spring-loaded gates is checked six monthly by a contractor and was last inspected and checked during April 2023. The drying rooms where the chute hatches are located are checked regularly and are protected by self-closing fire doors.

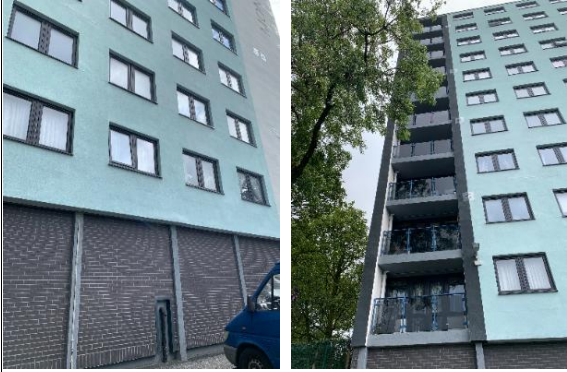
9.16	The general housekeeping in the premises is of a good standard.
9.27-9.28	<p>The previous FRA advised:</p> <p>The external façade consisting of cement-based rendered EPS insulation has been removed and replaced with a rendered mineral wool insulation without any cavities.</p> <p>Flats are provided with balconies that are part of the original structure and constructed of non-combustible materials. First Choice Homes Oldham displays a document that states not to use or store BBQs, gas cylinders, or anything flammable on the balconies.</p> <p>Some residents may store combustible household items excessively on the balcony which was not observed during the assessment. This forms part of the monthly common area check. The balconies observed were not unduly cluttered with household items with some having outdoor furniture and pot plants.</p> <p>Although not viewed on this assessment, it was previously advised that documentary evidence was obtained by FCHO from the principal contractor confirms that the materials forming part of the external wall conform to European Classification A2-S1 d0 or A1, classified in accordance with BS EN 13501-1:2007+A1:2009.</p>

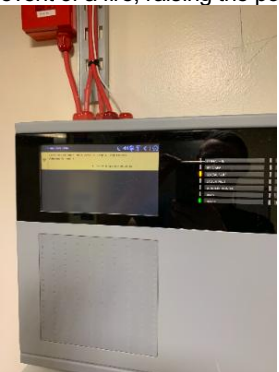
12.0 Fire Fighting Equipment, Facilities, Systems & Fixed Installations: Finding(s)	
Ref	SIGNIFICANT FINDINGS
	Observation
12.14	<p>The EACIE alert system was sounding with a fault at the time of the FRA. This was silenced by the FCHO representative, but a fault remained. Should there be a fault on fire safety systems, they may result in the system not operating as required in the event of a fire, raising the potential for persons being placed at risk of harm.</p>

12.14	It is recommended that the EACIE alert system be inspected by a competent person to ensure the system is fully functioning correctly.
Ref	RECOMMENDATIONS
	Observation

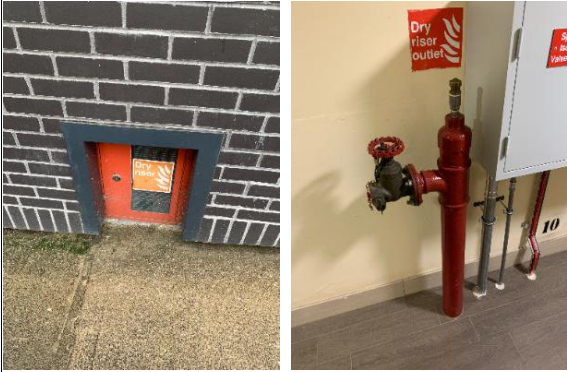
12.6-12.8, 12.10	<p>A dry riser is installed with outlets located on the lobby areas to flats. The landing valve leather securing straps that help to prevent unnecessary water discharge when the riser is charged are correctly located. The dry riser inlet is located by the entrance door to the block. As part of FCHO standard responses, where installed dry risers are subject to 6 monthly checks: full pressure check and visual inspection. Certification was viewed to show the latest service noted as 07/08/2023 by UK Dry Risers Ltd.</p>

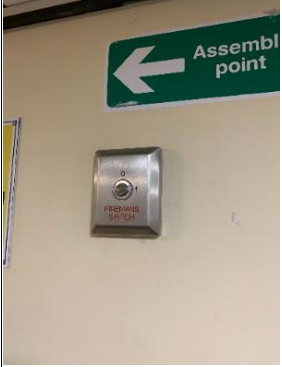
12.11-12.13	<p>Lifts with a Fireman's Switch function are provided on the two lifts within the building. Fireman's lifts were installed before fire-fighting lift standards were made available, incorporating only simple means to recall the lift to a designated floor, with no complex lift controls or protection measures for fire and rescue service use, also known as a fire service lift. Where the term "firemen's lift" is used it refers to a lift installed in accordance with BS 2655-1970 or BS 5655-1986 for use by the fire and rescue service. Firefighters will use a dynamic risk assessment on the use of the lift operationally due to the limited facilities it provides.</p> <p>The person consulted advised that the fire control function is in use and only brings the lifts to the ground floor.</p>

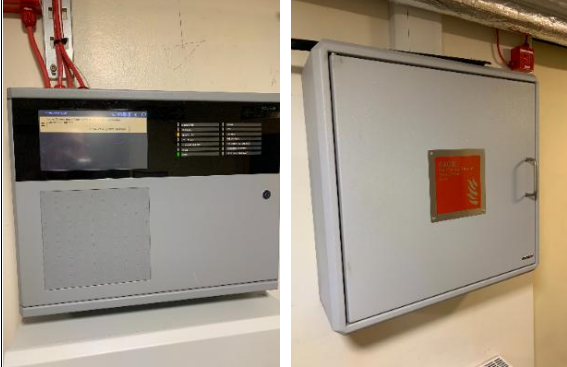
12.14	<p>A new Evacuation Alert System (EACIE) has been installed within the building. The EACIE is equipped with facilities for use by the Fire and Rescue Services (FRS), enabling them to send an evacuation signal to the whole or a selected part of the building by means of sounders or similar devices. Sounders are provided in the hallway of each flat that is linked to this system.</p>

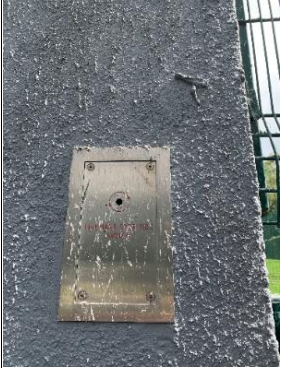
14.11	An override/fire control switch is provided externally above the entrance gate and door to the building for use by the fire service.
